# Old town of Kuldīga

Attribute mapping report for  
the UNESCO World Heritage  
property

Institute for Heritage  
Management

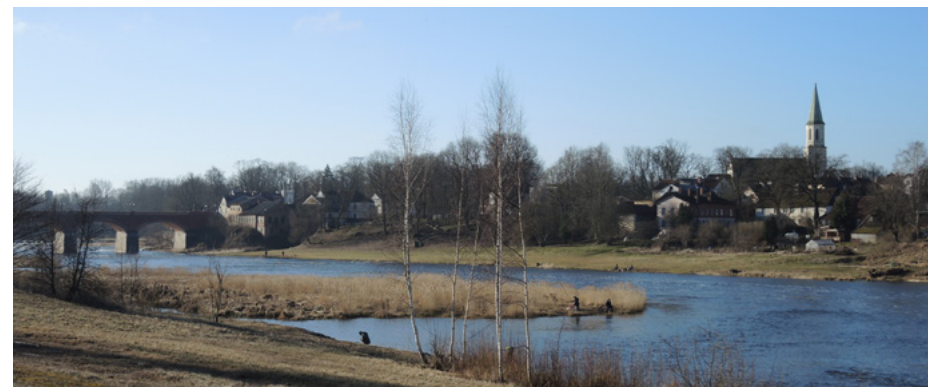
Figure 29: The town silhouette integrates the brick bridge, dwellings from ducal times as well as the different church towers (St. Catherine's Lutheran Church is visible in this picture)

Recognizing the exceptionality of Kuldīga's Old town, in 1977, local legislation established a height restriction for residential buildings within the Old town of Kuldīga. Today, the general construction rules of Kuldīga determine a maximum height of three floors for new constructions within the area of the cultural monument and its Individual Protection Zone. Since 2023, those areas correspond to the UNESCO World Heritage property and its buffer zone (see Nomination File, 113; 206). This measure helped prevent additional disturbances and largely maintained the proportions of an organically evolved town, showcasing the typical silhouette of urban development in the Baltic states during the second millennium.

The town's vertical dimensions allow future generations to meander through the setting of a traditional Baltic town, which is therefore considered a **highly significant** attribute of the property's Outstanding Universal Value.

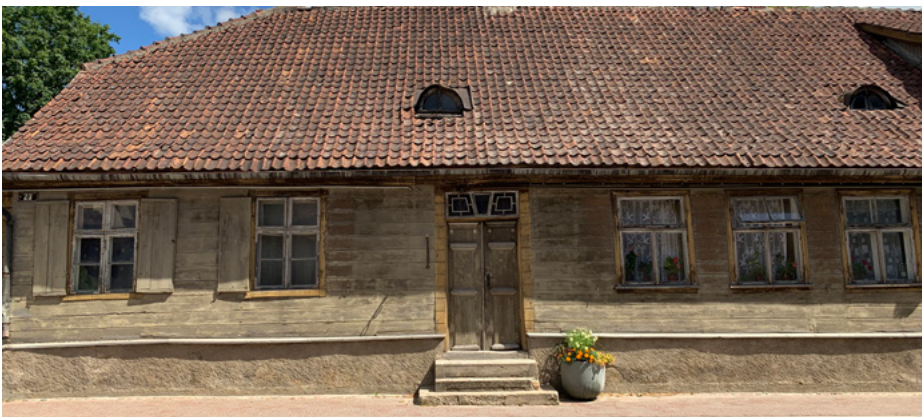
Figure 31: A traditional dwelling from the Duchy of Courland and Semigallia

(4.3.1 a) A vast majority of buildings located in the centre of Kuldīga originate from the era of the Duchy of Courland and Semigallia and retain significant amounts of building fabric from their time of construction. Due to their density, they are able to impressively recreate the experience of a 17th or 18th century

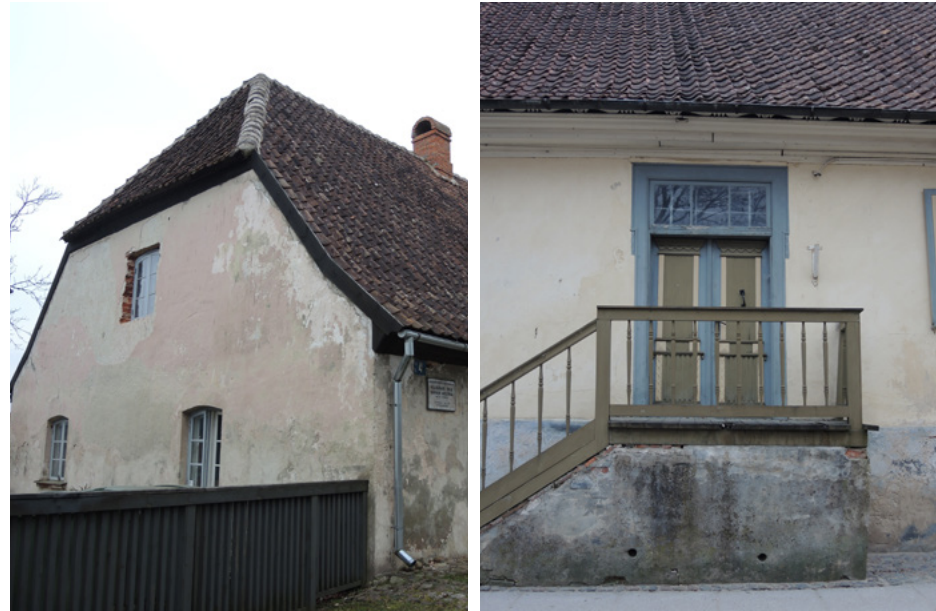
Figure 38: Stone buildings were introduced to Kuldīga during the Duchy of Courland and Semigallia

(4.3.4 b) In the 18th century, masons started their work in Kuldīga, and soon left their mark on the architecture of the town. The townscape shifted from a predominantly wooden one to a combination of wood and masonry structures. Despite its different characteristics, the buildings made from this new material, follow a similar style as the ones before, incorporating not only proportions but also architectural details such as stone plinths and delicate windows (see attribute 4.4).

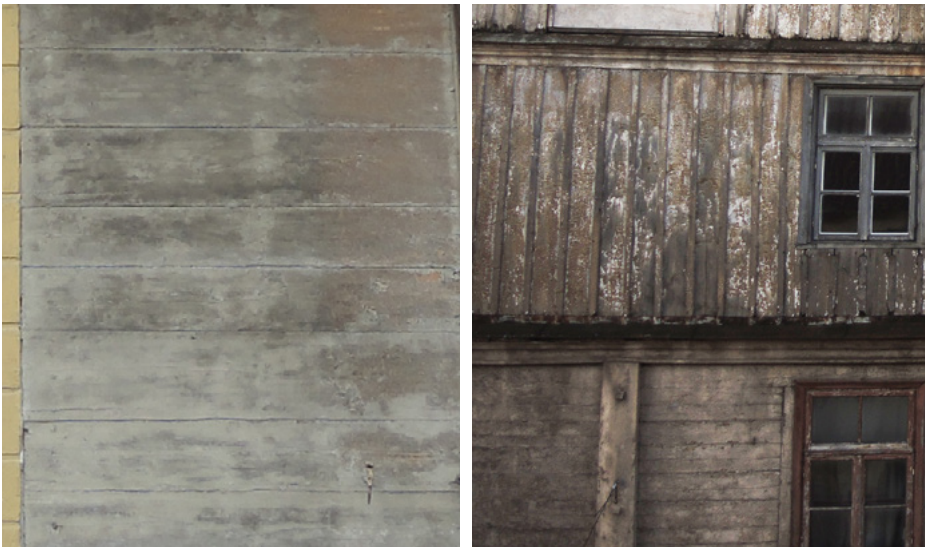
Figure 37: The earliest wooden facades remain without further decorations

The facades of wooden buildings changed throughout time and became more delicate in their design. They were often painted. Below the roof, cornices can be found, which changed from plain board cornices to more detailed designs.

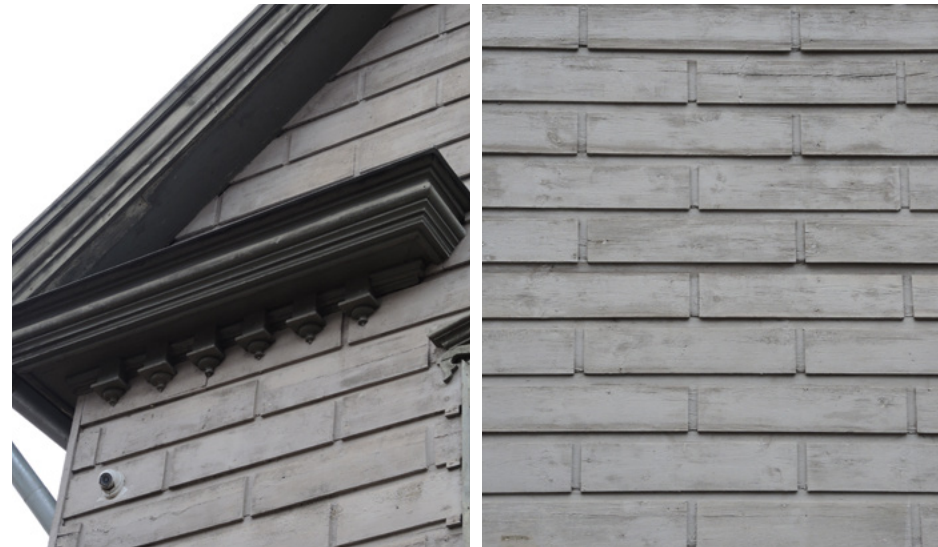
Figure 39: The façade of the building at Baznīcas Street 36 shows the typical façade design of later wooden buildings found throughout the Old town of Kuldīga, including delicately carved corner cornices

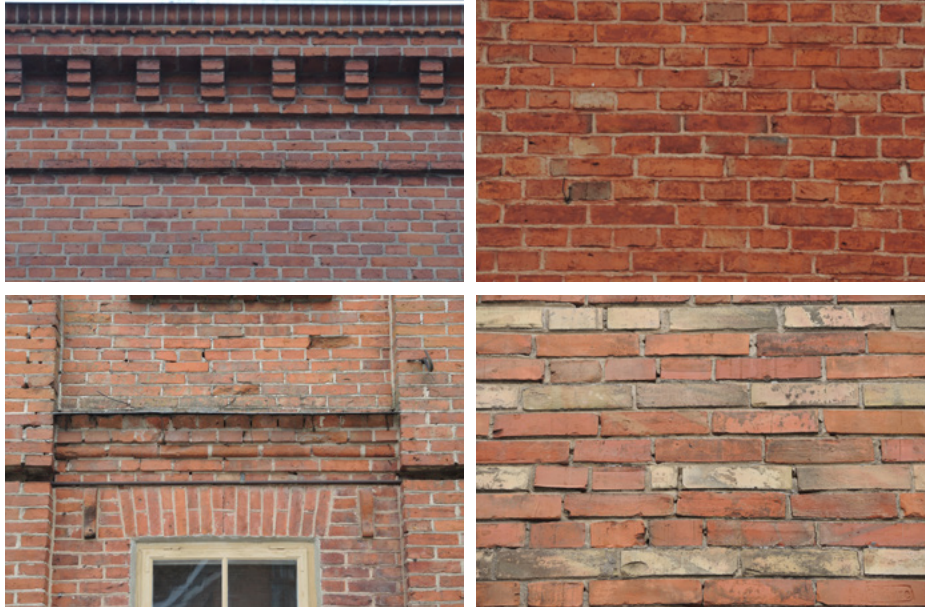
Figure 40: Red and yellow brick facades with brick cornices are common elements of Kuldīga's townscape

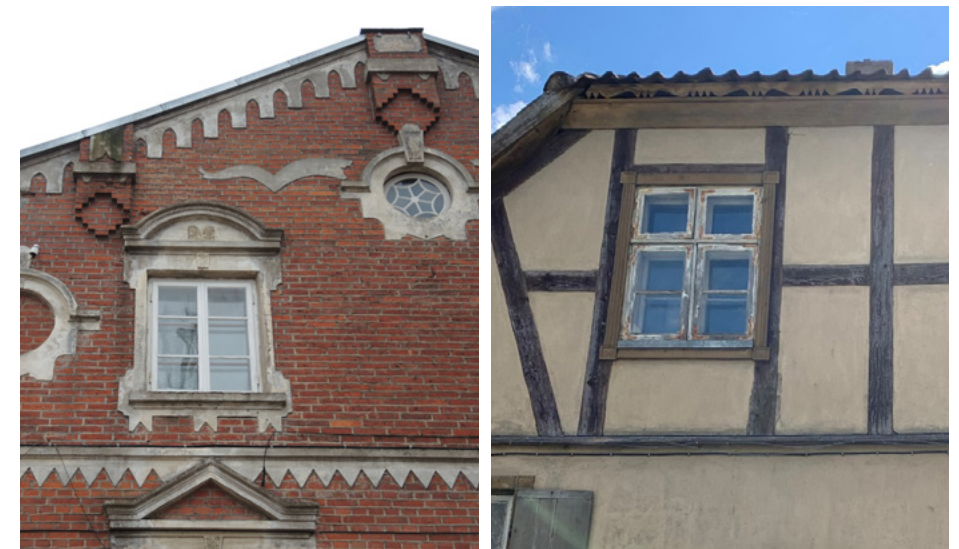
(4.3.4 e) As a result of the increasing exchange with craftspeople from other regions, building materials continued changing throughout the 18th century, leading to an increasing number of mixed-material buildings and half-timbered houses. Examples of the different combinations of building materials are found throughout Kuldīga and allow for a thorough understanding of how the political development of the region increased the introduction of foreign materials that turned into standard elements of regional architecture.

Figure 42: Mixed-method approaches (brick and plaster on the left; timber-frame on the right) show the different foreign influences and their fusion into new architectural styles

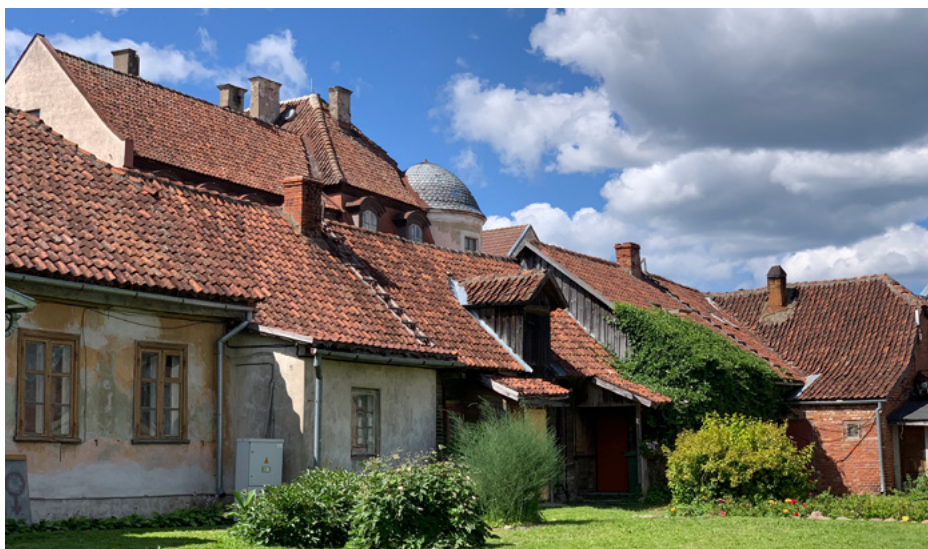
Figure 43: The roofscape of Kuldīga mirrors the 19th-century building regulations that aimed at preventing fires from spreading

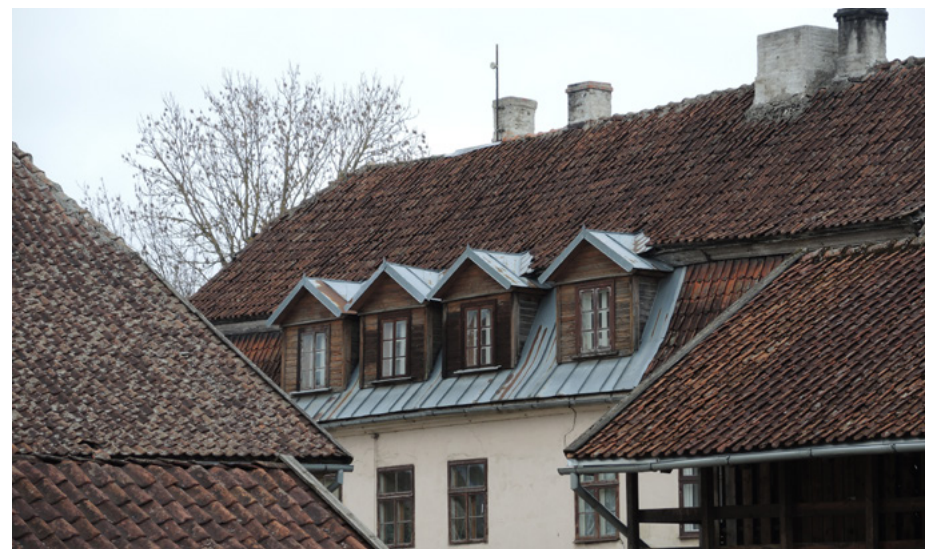
Figure 44: The roofscape of Kuldīga mirrors the 19th-century building regulations that aimed at preventing fires from spreading

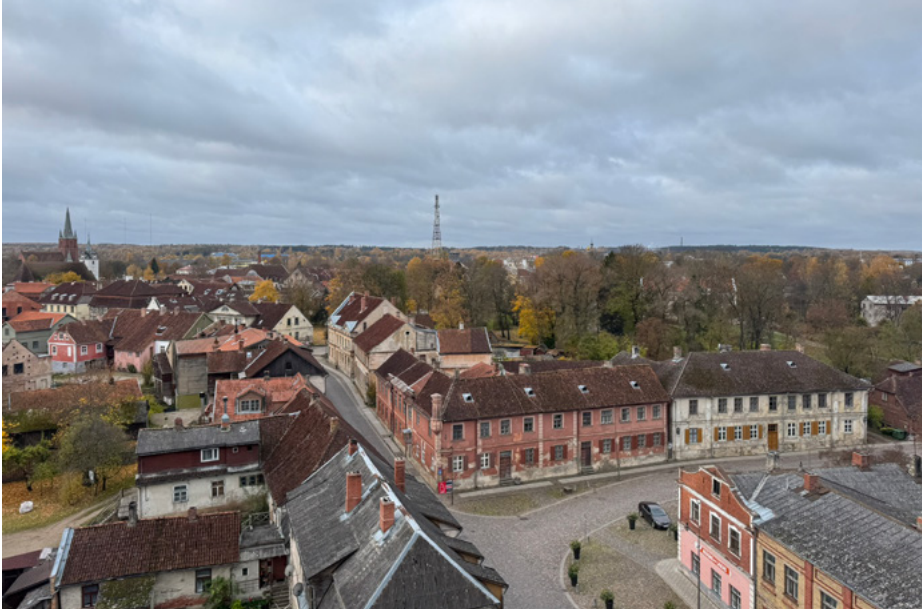
Figure 45: The western view from St. Catherine's Lutheran Church provides a unique view of the different building materials and the vast clay roof landscape of Kuldīga

(4.3.6 a) The view corridors from St. Catherine's Lutheran Church are unique in that there is no other historical viewpoint within the town from where the old town can be observed from above. The views towards the north, east, south and west all allow for a particular appreciation and understanding of the property's diverse attributes. From St. Catherine's Lutheran Church it is not so much the view towards the horizon that is of importance to the property's OUV, but the view onto the vast clay roofscape that can be seen in all directions. The view corridors from St. Catherine's Lutheran Church are considered **highly significant** attributes of the property's OUV.

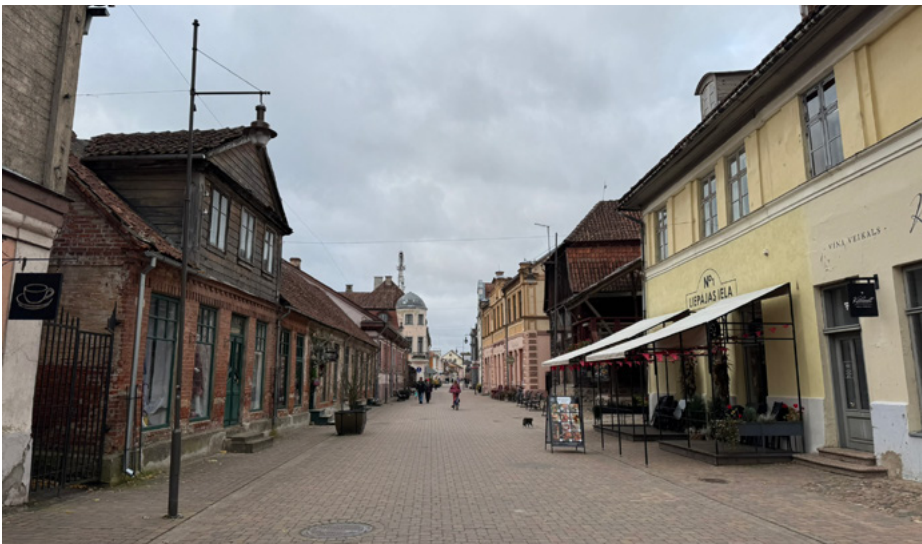
Figure 46: The view along Liepājas Street integrates residential and auxiliary buildings from different periods and materials

(4.3.6 b) Liepājas street is the main pedestrian road of Kuldīga and holds particular value for the communication of the property's changing architectural styles since the Duchy of Courland and Semigallia. Like no other view, this view encompasses a variety of attributes of architecture and building fabric, with buildings of different materials and times of construction. Both the ducal era and the Russian Empire can be distinguished within this view. The visible attributes are mainly residential buildings from the different time periods as well as a warehouse from the Ducal era in the view's foreground. The view corridor along Liepājas street is considered a **significant** attribute of the property's OUV.

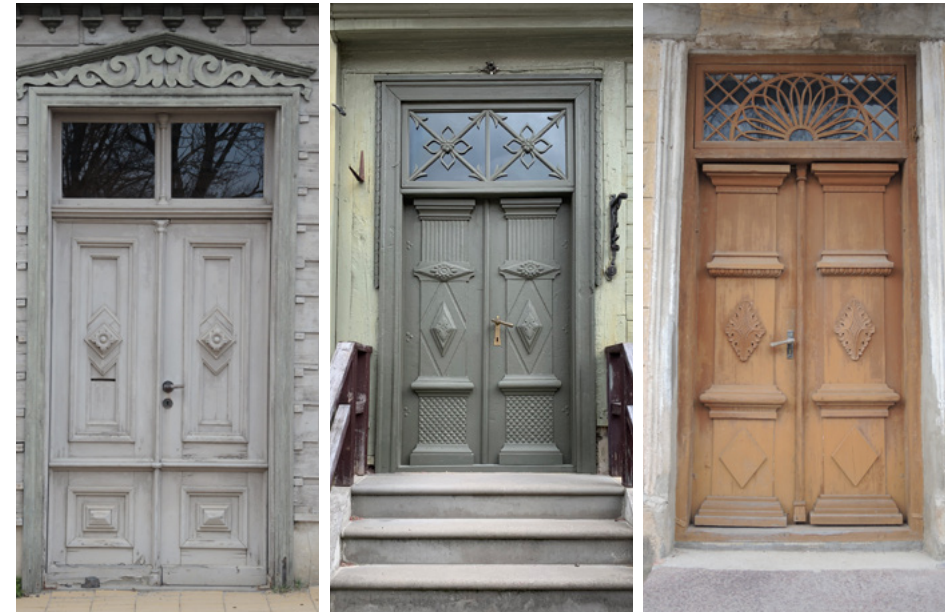
The wooden doors found across Kuldīga all share delicate ornamentation with traditional Latvian patterns carved into them. Those patterns often have a somewhat floral characteristic. The doors are made from local materials and include a decorated window above the two door wings, so that lanterns could be placed inside the house (see attribute 4.4.5 c). Today, restorations of those doors are carefully organized through Kuldīga’s Restoration Centre, where the use of traditional techniques and materials is of utmost priority.

Figure 52: Wooden doors in the Old town of Kuldīga

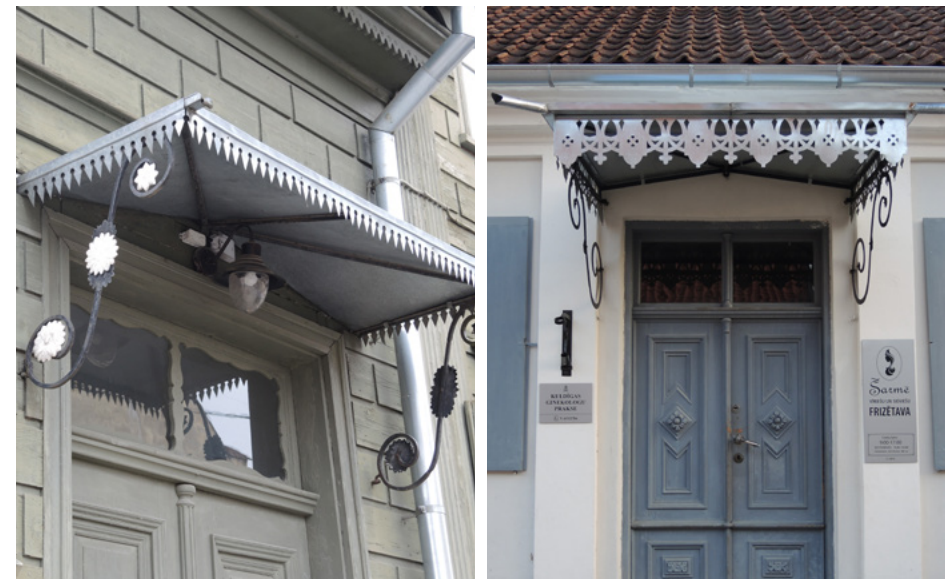
The canopies, as well as the continuity of their restoration, are considered **significant** attributes of OUV.

Figure 53: Restored canopies above the traditional doors

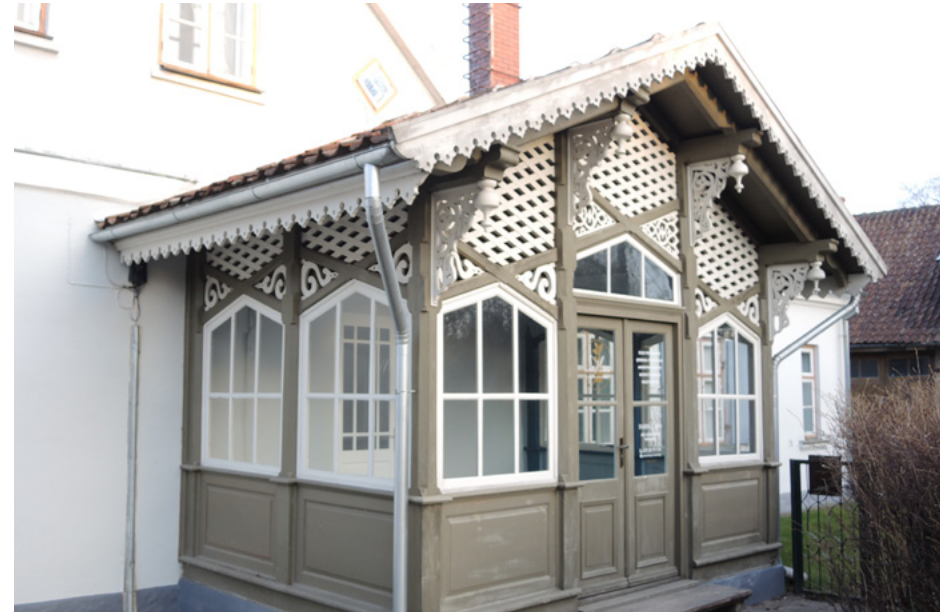
Figure 54: Porches offer a sophisticated entrance area and exist in closed (here) and open form

Another element of traditional craftsmanship that influences Kuldīga's architecture, are porches which are found in the backyards of several buildings. These porches are elegantly carved from wood and provide for impressive entrances. They exist in an open and a closed design. Sometimes, tin elements similar to those of the canopies, are found along the edges of the porches' roofs.

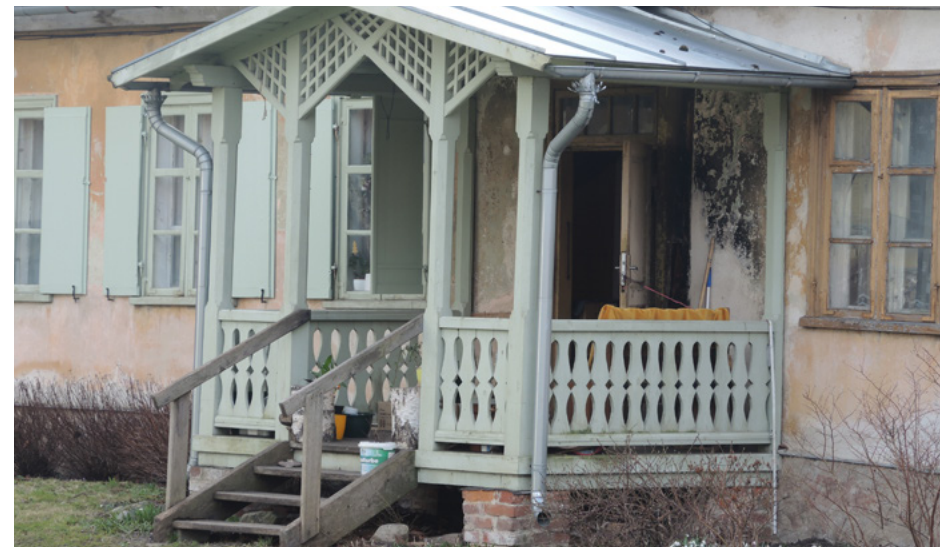
Figure 55: Porches offer a sophisticated entrance area and exist in closed and open form (here)

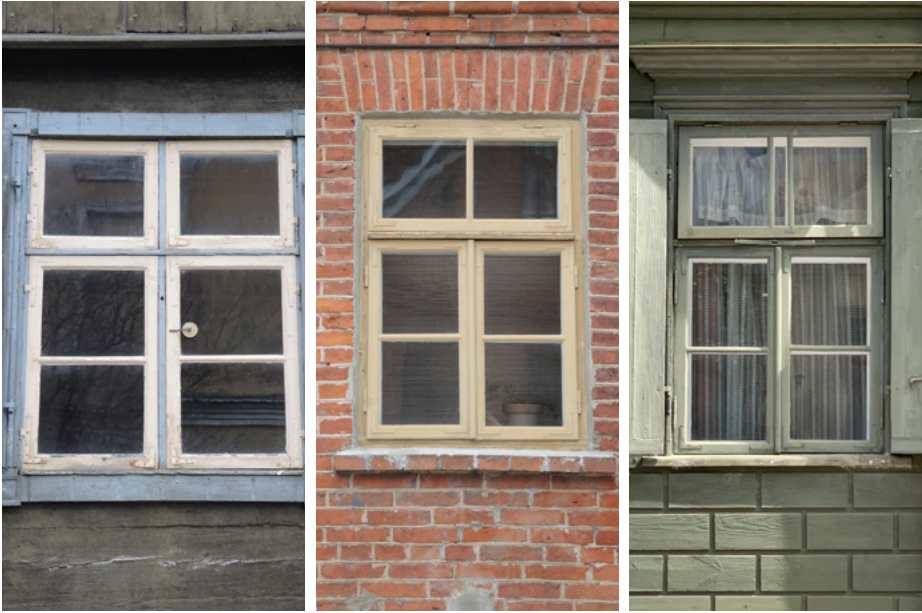
Figure 56: Examples of different front façade windows show the continuous style of the windows throughout different building periods

Another element displaying the continuity of the extraordinary craftsmanship found throughout Kuldīga are the different types of windows.

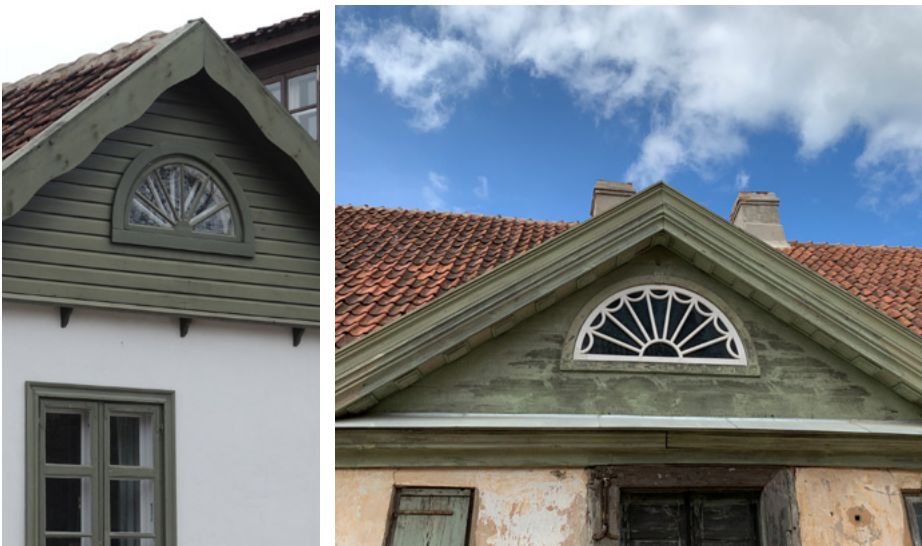
Figure 57: Gable windows with ornamental details are typical elements of local craftsmanship

(4.4.4 b) In addition to windows on the front and back facades, there are also some additional windows that are typical elements of craftsmanship of the Old town of Kuldīga. One example are gable windows which impressively illustrate the skilled work of local craftsmen and which showcase that windows in the Old town of Kuldīga are more than just a functional element. Those gable windows were first introduced during the Duchy of Courland and Semigallia. Similar to the door designs, the window designs often draw from floral patterns of the surrounding landscape.

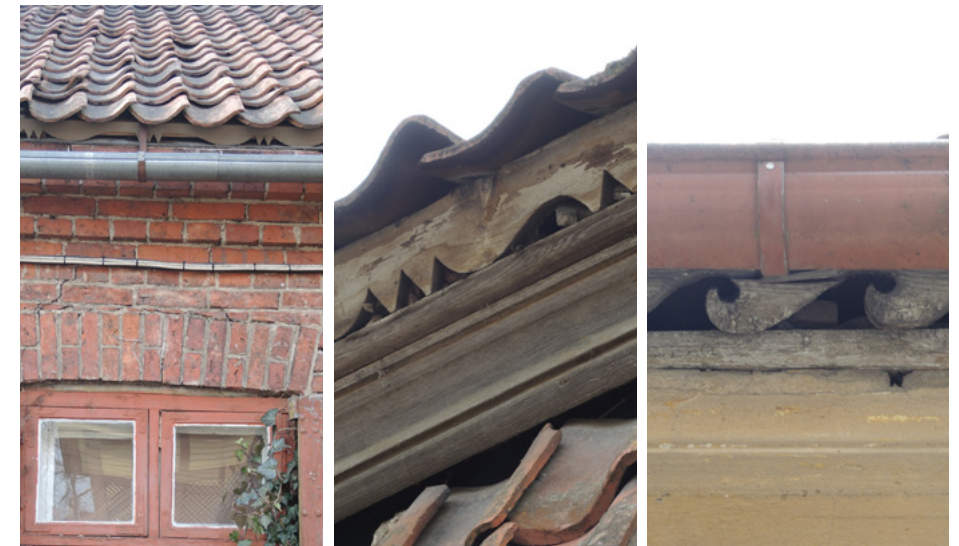
Figure 58: Different windboard design are found throughout Kuldīga.

For functional reasons, windboards are installed between the roof and the façade of a building. These windboards are common elements of architectural design and have a long tradition. In Kuldīga, those windboards, which are traditionally made from wood, have been turned into ornamental details, hence combining functionality and aesthetics. Throughout time, the design of windboards has changed, making it possible to understand the timeframe of its creation based on the specific design. Older designs typically include some spikes along curved lines, or have rectangular carvings, whereas later designs have more of a wave-like design.

The windboards are considered **significant** attributes of OUV.

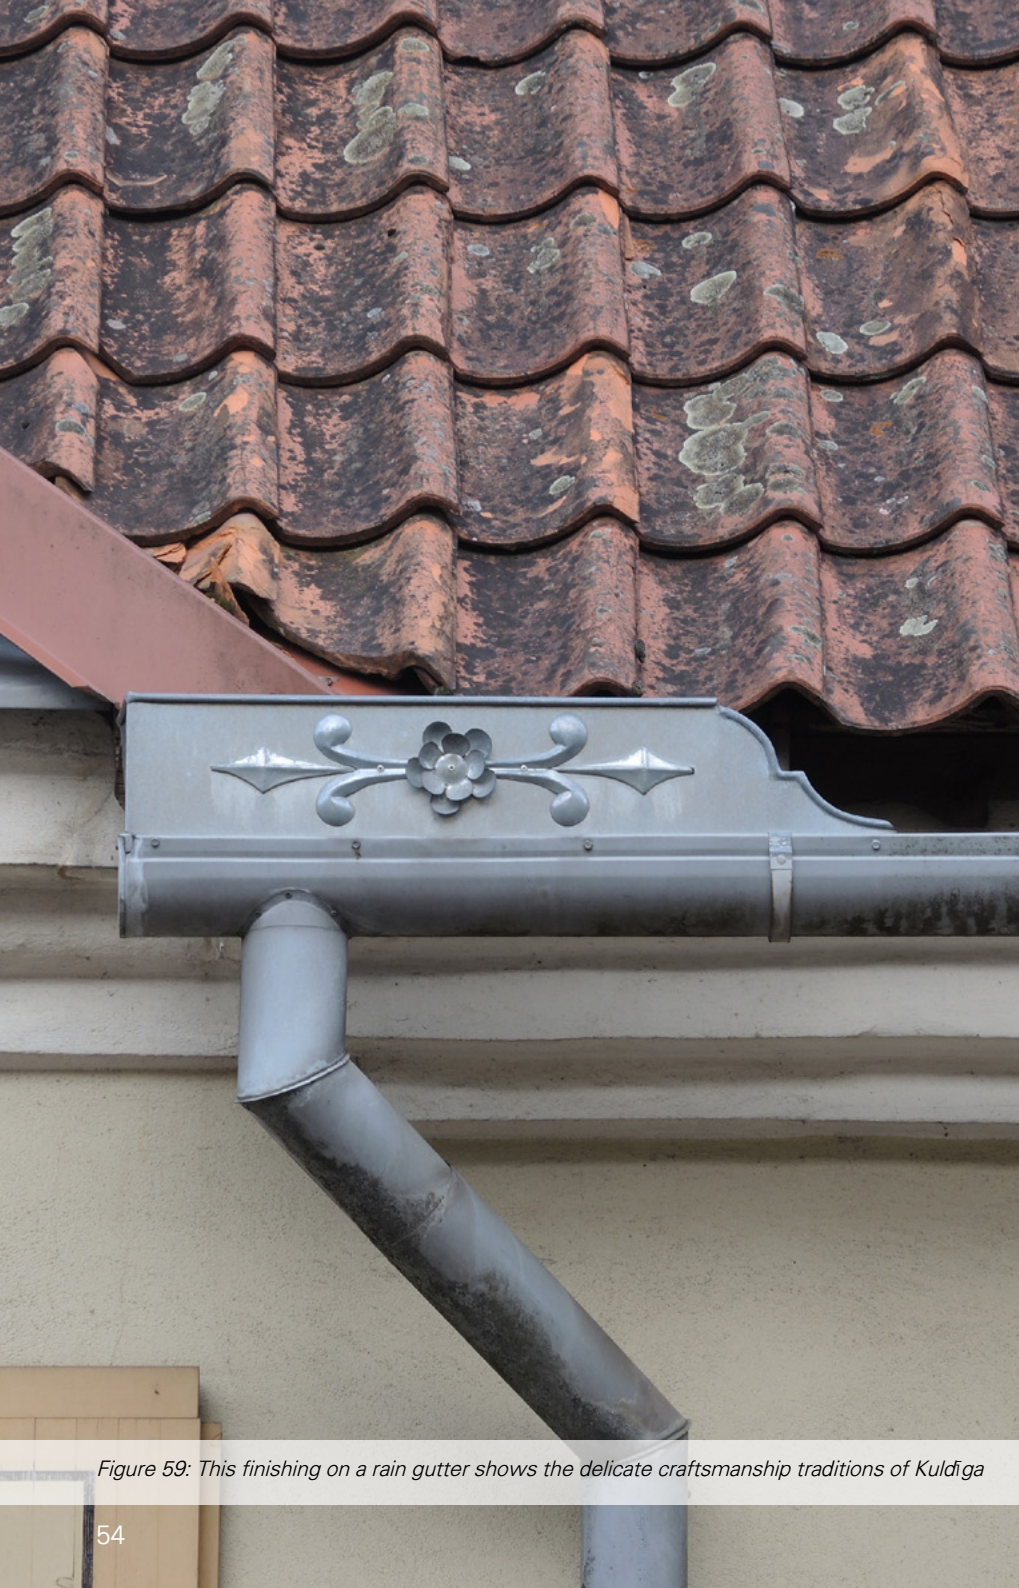
Figure 59: This finishing on a rain gutter shows the delicate craftsmanship traditions of Kuldīga

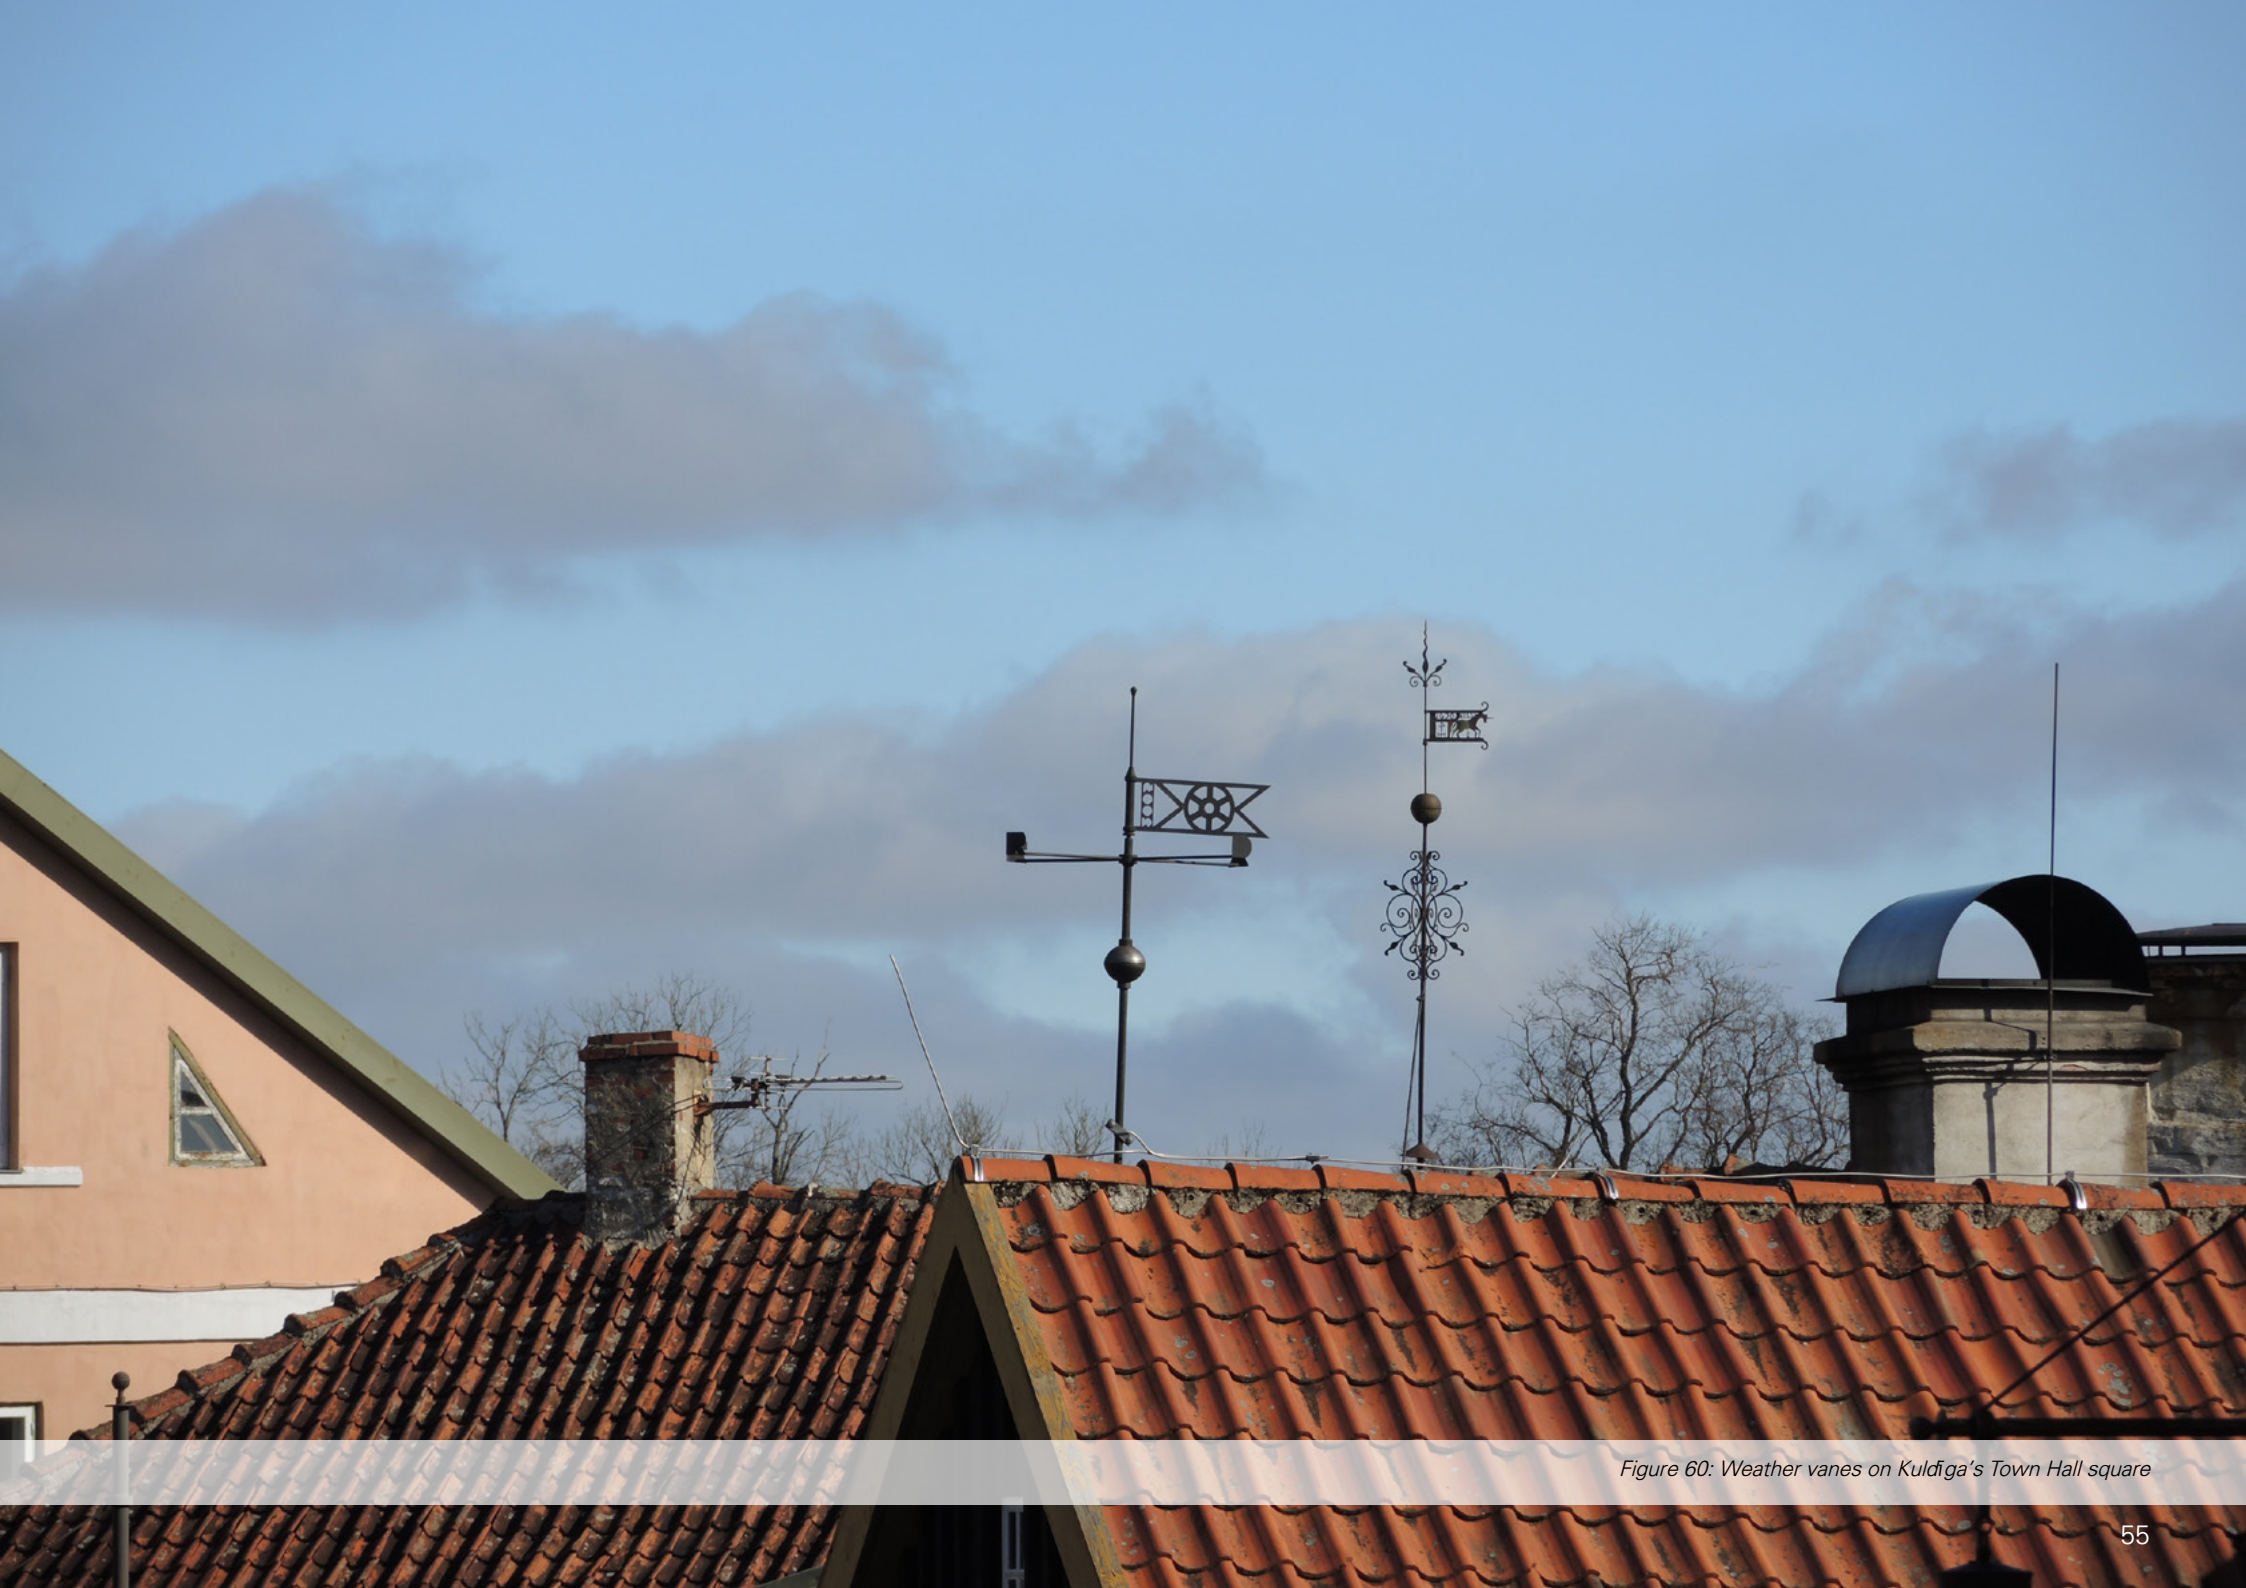
*Figure 60: Weather vanes on Kuldīga's Town Hall square*

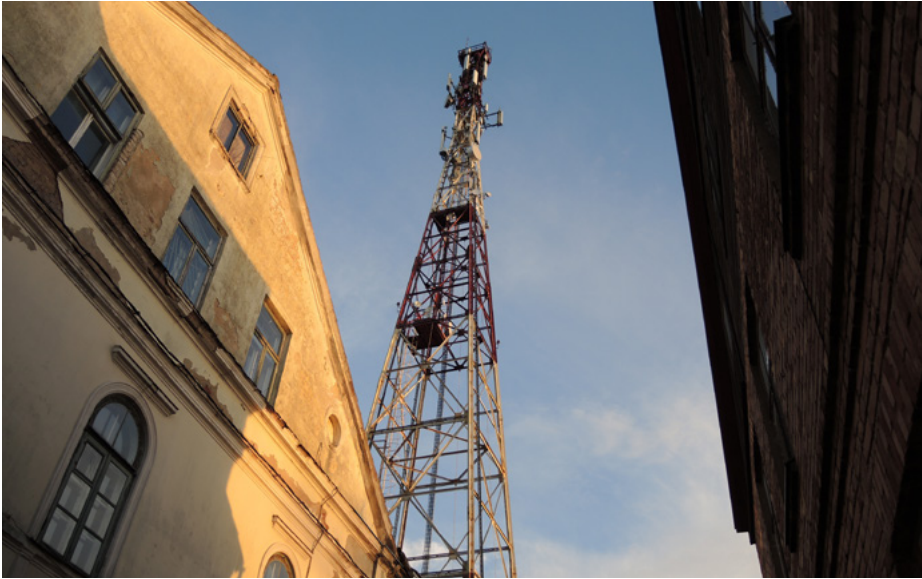
Figure 62: Radio tower next to the police station

(4) It is recommended to consider relocating existing disturbances to the OUV, especially radio towers, to recreate the historical silhouette of the town. It is furthermore recommended to further analyse whether it would be possible to change the colour of the hospital's roof to a more neutral tone that blends in with the historic roof landscape. In the future, roofs that might be visible from the view corridors identified to be of OUV relevance should always blend in with the historic colours, if possible. Heritage Impact Assessments are a key tool to prevent similar disturbances in the future.

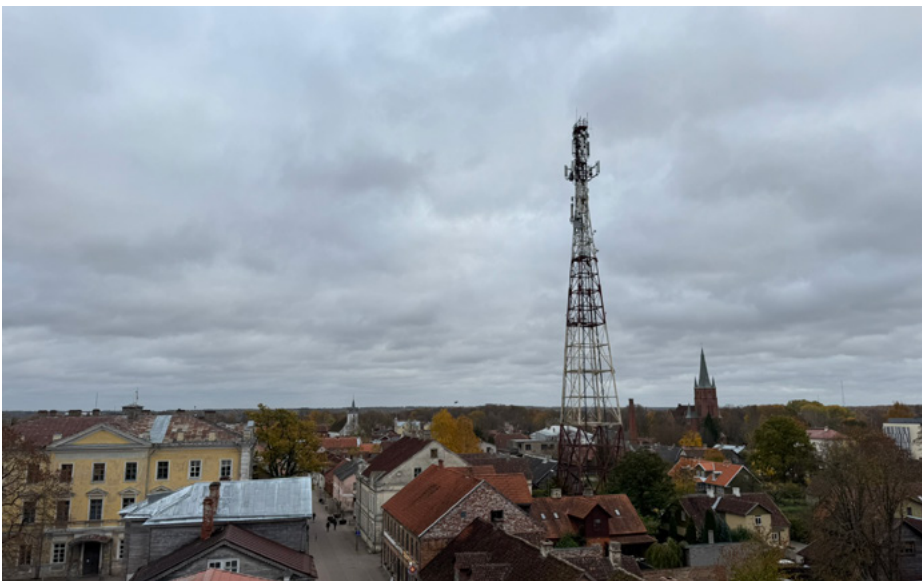
Figure 63: The radio tower in the buffer zone interferes with the view of the town silhouette

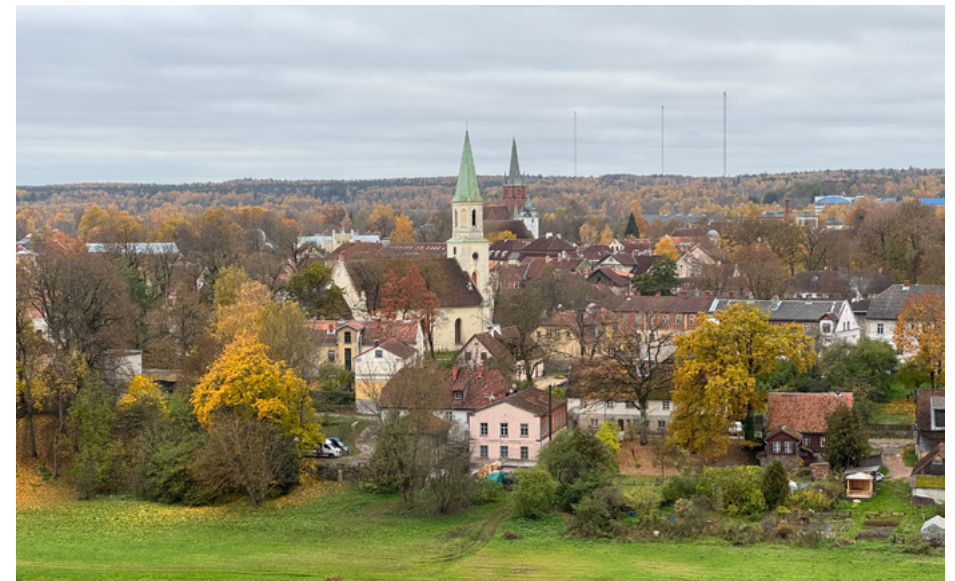
Figure 64: Radio towers near Upīškalns in the wider setting

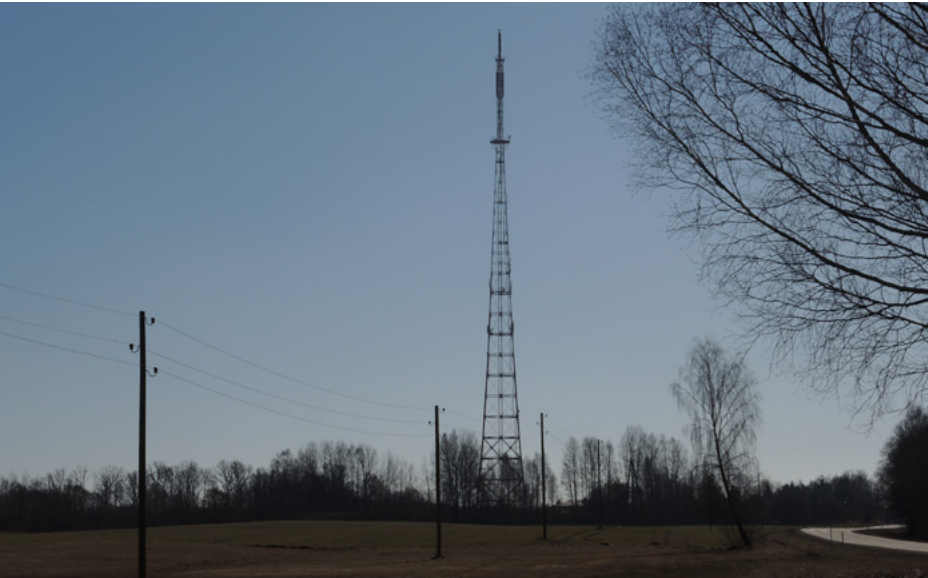
Figure 65: The radio tower next to Abele is clearly visible behind Ventas Rumba waterfall

This radio tower is a singular structure which is located outside Ābele. In contrary to the previously mentioned radio towers, this tower appears in the background of the Venta Valley and the brick bridge when looking at them from the north. As this view is considered a highly significant attribute of OUV, based on its continuation of the historic perspective (see attribute 4.1.5 a), this disturbance is to be seen critical. If possible, it is recommended to consider relocating this tower. No additional interferences with this important viewshed should be tolerated in the future.

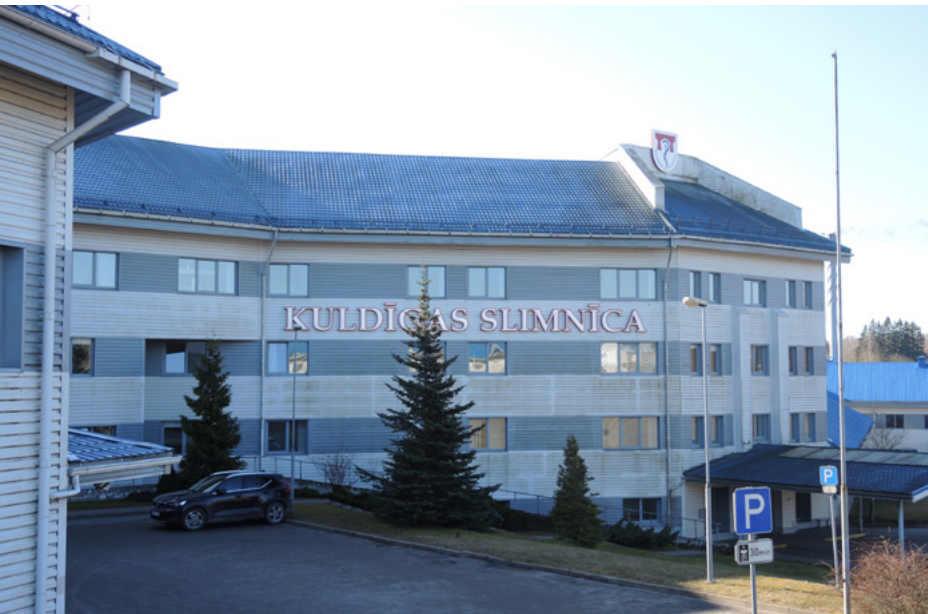
Despite being only four stories high, the hospital of Kuldīga, which is situated in the property’s wider setting, distracts from Kuldīga’s silhouette due to its blue-coloured roofs. While the height of the building does not harm the property’s OUV, it is recommended to further analyse whether it would be possible to change the colour to a more neutral tone that blends in with the historic roof landscape. In the future, roofs that might be visible from the view corridors identified to be of OUV should always blend in with the historic colours.

Figure 66: Due to its location on a small hill west of the town, the roof of Kuldīga’s hospital is visible behind the town silhouette
