# **PRACTICAL GUIDE**

Measures for heat loss prevention in historical buildings, using the experience of the Baltic and Scandinavian States

# A guide for "The Measures for Thermal Loss Prevention in Historical Buildings, Based on the Experience of the Baltic and Scandinavian States"

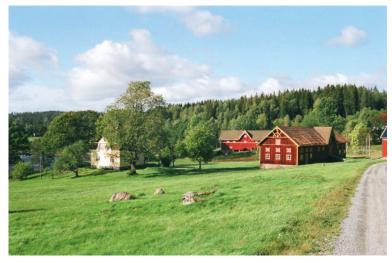
Using vegetation to shelter houses from wind is an old tradition. It is an efficient way to reduce heat loss significantly. Photo: Marie Odenbring Widmark

Identical houses in different landscapes and climates are likely to behave differently and therefore require different actions. Investigate how the building relates to its environment. How is it exposed to wind and sun? Is it sheltered by trees or hills, for example? Question the possibility to modify the microclimate around the building. Using vegetation to create shelter can actually reduce heat loss by up to 15%.

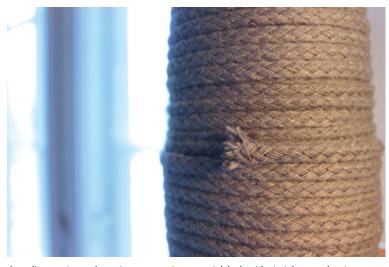
According to science, the main energy saving potential deals with air tightness when it comes to historic buildings. Sealing windows is a cheap and simple solution that will have significant effect on the energy bill. The strips comes in various materials, sizes and shapes. Cords made of wool is an example of a product that is flexible and repels water. Photo: Carina Carlsson

The strips come in various sizes and materials: rubber tubes, hemp or wool for example. When sealing double glazed windows, the strips must be mounted along the inner frames and not the external ones, in order to prevent condensation.

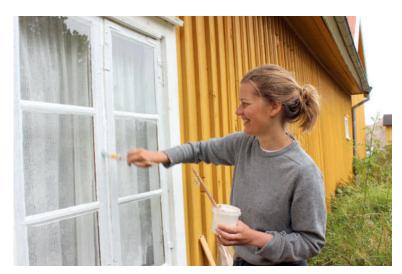
There are many reasons to save and renovate old windows instead of replacing them: economical, aesthetical and environmental, to mention some of them. With the help from a skilled craftsman, they can be improved in different ways without impact on the character. Or take a course and learn how to renovate them yourself. Photo: Ulrika Lindh

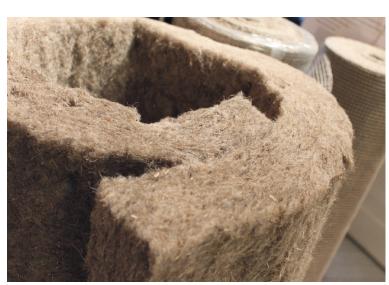
In recent years, several types of building insulation materials with low environmental impact have emerged. Insulation made of flax is one of those - a light, durable material with hygroscopic properties. Photo: Jonas Ulfsfält

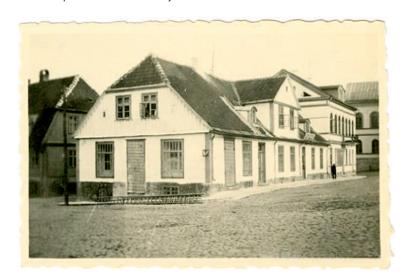
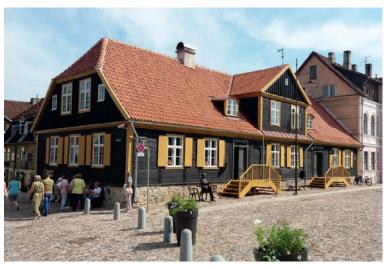
The building in the beginning of the 20th century — with wall rendering on the wooden log house walls<sup>3</sup> and the building after the renovation — in 2016

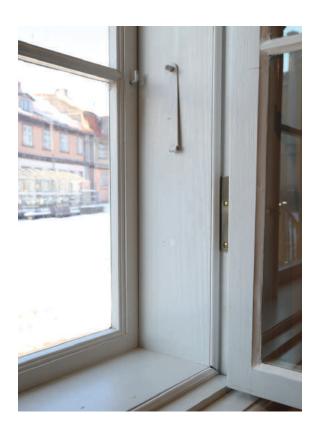
The restorable window with the applicable sealing parts in it – rubber sealing gums and the window glazing with a putty appliance in the external sashes<sup>12</sup>

In this building, the windows were manufactured during the process of renovation — in the second part of the 20th century — that is, in 1973, the window glasses were fixed with laths. It was cheaper, but less economical. When humidity and moisture get beyond a lath, the glass bedding rifle was damaged and through such gaps the air-flow got in.12

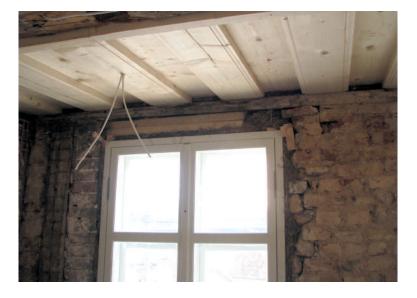
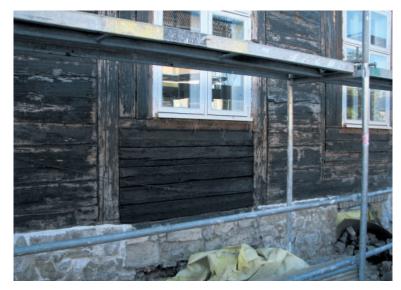
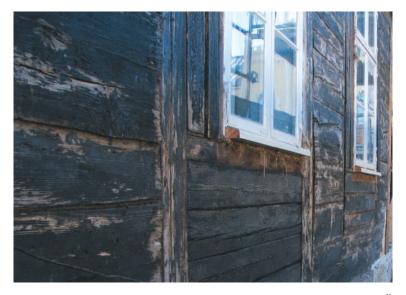
The window block application in various material walls with the supplements – flax tows<sup>13</sup>

restore the external window sashes (manufactured in 1973) with a caulked window but produce new internal window sashes by introducing an innovation — to use a reflective glazing, which was not possible historically. It is discussed in more details in Chapter 7.3. The second place where the cold air-flow could come into the building, are gaps between the window sashes and their frames, and in order to prevent this – there were gaskets moulded (a rubber sealing contour) in the window sashes — cushion rubber of capron. It is possible also for inhabitants to purchase glued cushion gum rubbers for household necessities, but a more sustainable solution is to mold the gum, which is a more complicated, more expensive process though, as it must be performed by a craftsperson. For historic-type chamfered windows and box-type or lined windows, the rubber sealing contours are often embedded in the inner sash block. In order to ensure the best fixage density, it is necessary to individually evaluate the size of every rubber sealing for every window separately, to ensure that the density and compactness is enough for every window individually, not standardised and the same for all windows of the building. It is necessary to place an adequate rubber sealing cushion gum in the appropriate necessary thickness and length, with especially careful attention to corner connections, in order to prevent heat loss as much as possible. The third place where the most heat loss appears (visually observable), is the window frame fastenings in the wall, as the fibre tows were used as the only material, sealed on the surface. Traditionally before using them, the fibre tows were soaked in gypsum and then the tows gained more density. In such situation, they not only drain the moisture, but also accumulate it. Outside the wooden log house here, it was not possible to apply a plastering or wall rendering in such technique as it is done for masonry buildings the wall rendering was applied only in the interior where it is not flexible enough, which caused heat loss in this place. Probably the fibre tows should have been sealed more closely or chose modern-day materials which could be visually covered with window frame but would fulfil its function more effectively.

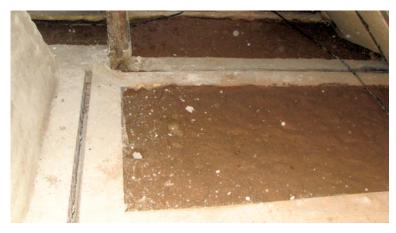
The removed and repeatedly laid clay covering

In the attic, the clay was used a material for thermal insulation, which was dismantled and repeatedly inserted back in the building after the constructions were strengthened. The clay coverings have not only isolating role, but it is also of high density and quite heavy, which

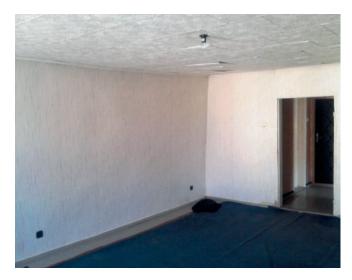
Before the renovation. The renovated and reconstructed premises in the end of the 20th century – in  $1973^{18}$

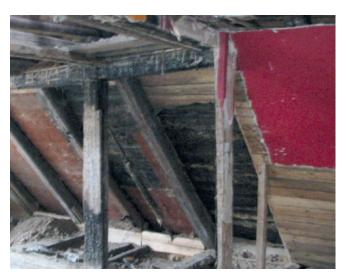
The renovation processes. The cold porches and their construction

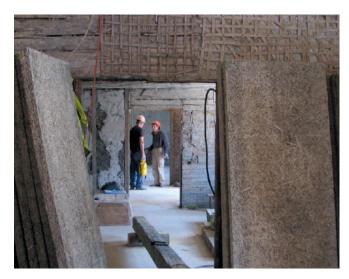
And their dismantled materials which were used in 1973 for reconstruction, including the fibrolite boards

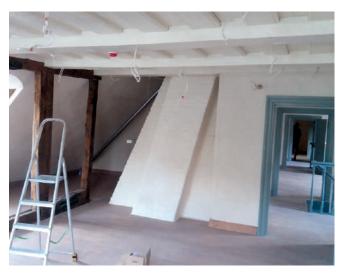
After the rebuilding reconstruction. The cold porches incorporated with the heated and usable premises

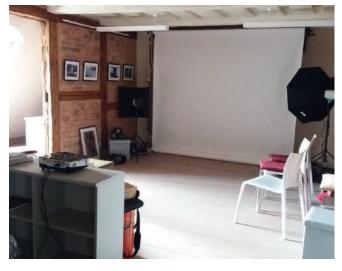
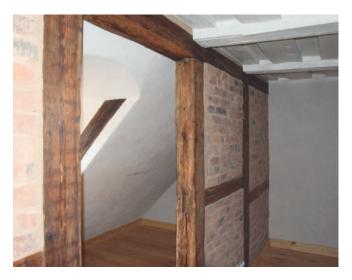
After the rebuilding renovation. The cold porches partly incorporated with the heated premises — with some openings in the filled framework walls, in order to ensure more lighting from the built-in roof parts

After the rebuilding renovation. There is a rendering on the fibrolite boards — as a solution which is still open for discussions, especially in a historical building where after the reconstruction the building still sinks a bit more into the ground, and there are some cracks revealed among the <sup>19</sup> boards, and consequently also in the rendering coverage of the wall. It is advisable to cover such interior rendering with some wood boards, where there would be no visible cracks

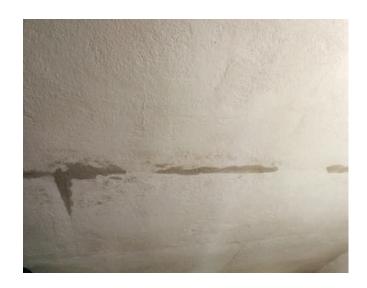
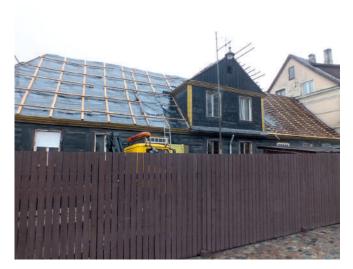
On the roof – diffusion film – under the cover – clay roof tiles

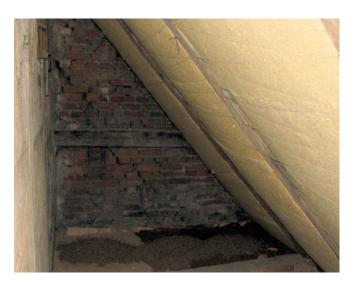
The insulation of roof board with wood fiber boards

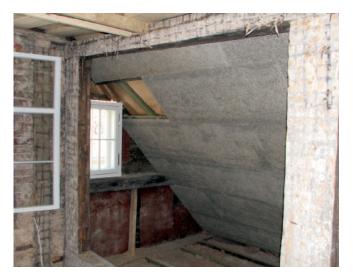
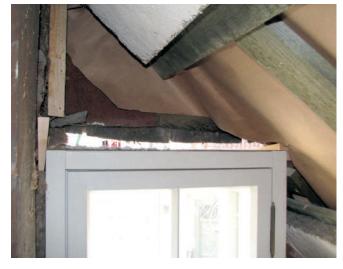
There are a steam barrier, laths and fibrolite layer placed above the wood fiber boards, afterwards the layer of the lime mortar rendering

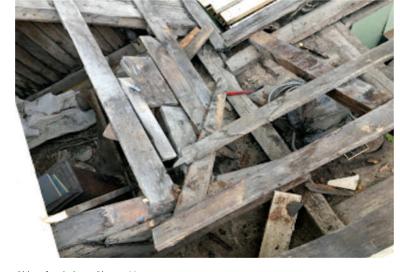
Old roof underlayer. Photos: J.Laineste

The roof covering was depreciated; the roof underlayer was partly missing. The old roof was removed and a new roof underlayer was build. The roof covering was replaced with hand-rolled zinc roof sheets. Just a couple of firms can provide hand-rolled metal roofs in South-Estonia, often pre-rolled sheets are used. At the Vambola street house historically the roof had been hand-rolled and the new one was made the same way. To prolong the life-cycle of the roof the metal sheets will be painted with linseed oil paint in a few years (after the zinc layer has abrased). Some of the funnels of the rainwater system were preservable, the rest were replicated.

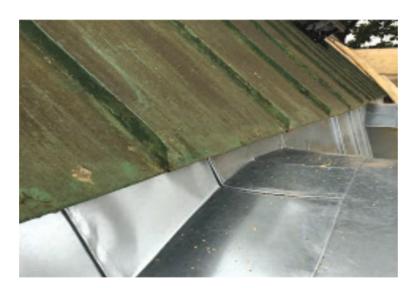
Replaced roof covering

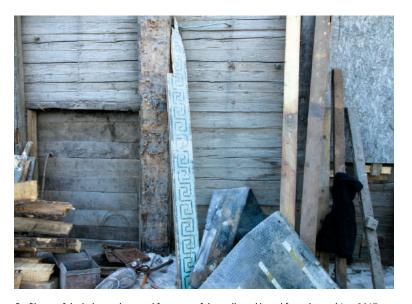
$Profile\ cut\ of\ the\ balcony,\ damaged\ fasteners\ of\ the\ walls\ and\ board\ from\ the\ vaulting\ 2017$

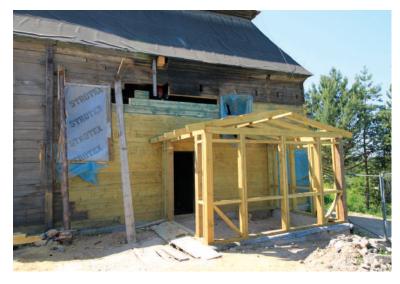
Restoration of wooden wall: implants and partial change of logs 2017 (photo M. Veliulis)

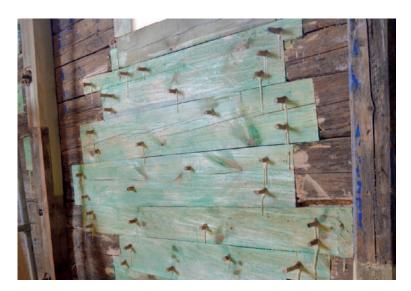
Restoration of wooden wall: implants and partial change of logs 2017 (photo M. Veliulis)

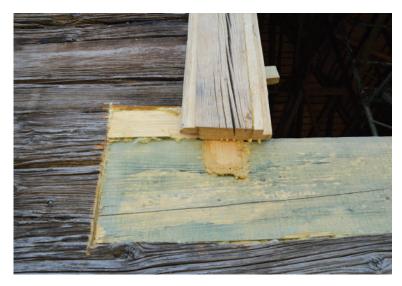
Inappropriate restoration of window frames 2017

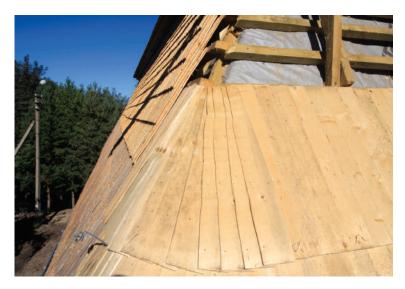
Spruce shingle roof covering 2017.(photo M. Veliulis)

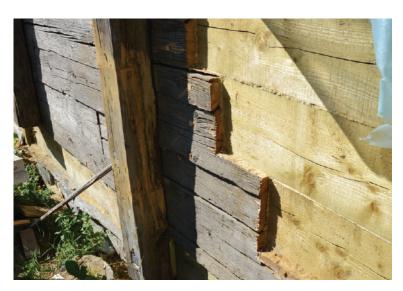
Wall insulation and boarding of the sinagogue 2017 (photo M. Veliulis)

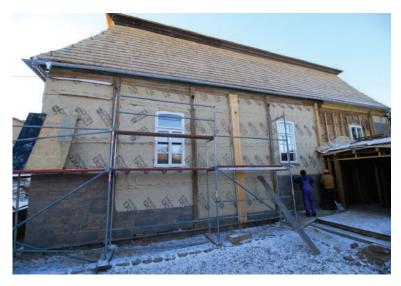
Wall insulation and boarding of the sinagogue 2017 (photo M. Veliulis)

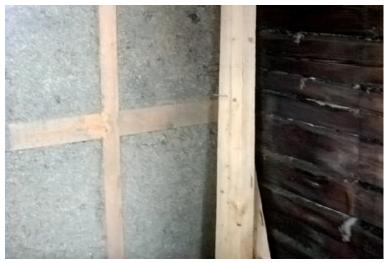
The external vestibule's framework was insulated with 150 mm of wood fiber blown directly on the frame. Photo in 2018, Hanna Elo

The ceiling insulation was thickened with around 300 mm layer wood fiber plates installed onto the existing moss layer of which the thickness varied from 200 to 300 mm. The external vestibule's framework was insulated with 150 mm of wood fiber blown directly on the frame. These half warm vestibules are an effective method in saving energy by preventing heat loss in the winter time. In the kitchen, of which the vestibule is unenclosed there is a double front door.

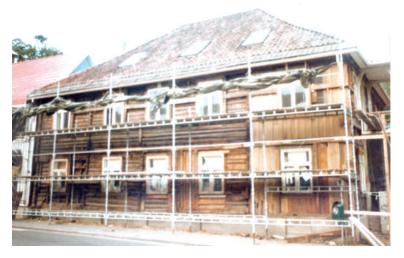
This photo was taken during the work in 1984, and we can see the main part to the left with log walls, and the frame work section to the right. A painted window on the wall in the framework section, to give balance in the facade, is visible in first floor to the right

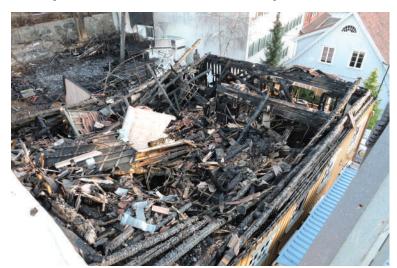
A sad view down in the fire plot, where the roof construction has burnt and fallen down on first floor. Pretty horrible chaos! The whole building was close to collapse!

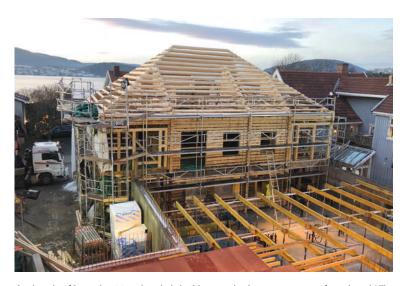
On the 5th. of December 2017 the whole building was back in town, risen up from the ash! The roof construction contains of 850 meters of round logs. In front is the roof of the new kitchen under construction. The kitchen will be moved outside the old building

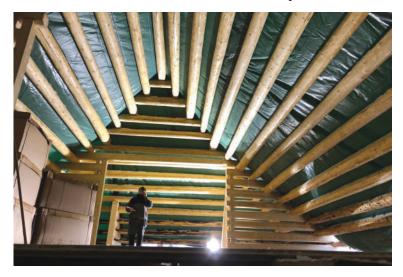
Inside the attic before the ceiling is put on top of the logs

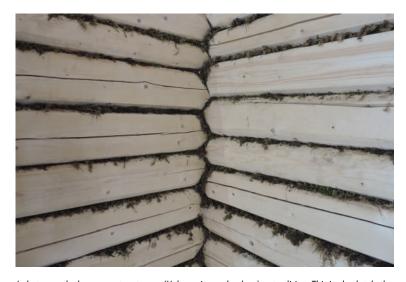
In between the logs we put wet moss (Hylocomium splendens) as tradition. This is absolutely the best material for this purpose, and is used all over Norway, Sweden and Latvia.

In 1984 the building was insulated for the first time, outside the walls, in the attic/roof construction (new apartment), and it got new windows. It was used Rockwool mineral fibres as insulation at that time. The strategy for the heat loss prevention measures in this building, is a combination of old insulation materials and new materials. When the building was rebuilt, the main part of the original building had spruce logs in the walls with 7" thickness, and moss (Hylocomium splendens) were put in between the logs, as tradition.

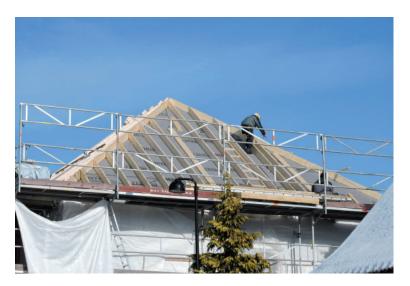
The roof insulation will be put in a rafter construction on top of the ceiling

- F. The roof construction with horizontal logs is visible from inside of the apartment, and the insulation will be put in a construction above the ceiling.

On top of insulation is a wind stopper. Outside the wind stopper is an 2" wide opening for ventilation. On top is red clay tile.

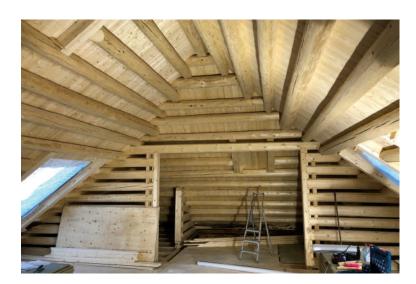
Inside the attic/apartment after the ceiling has been fastend

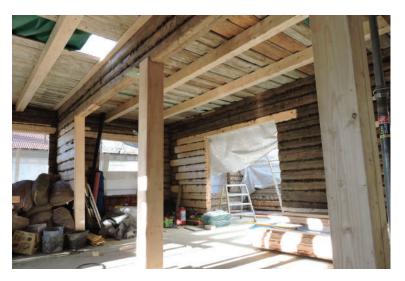
Inside to rooms in ground floor, where we see original ceilings and log walls. The ceiling joists and part of the walls had to be made new

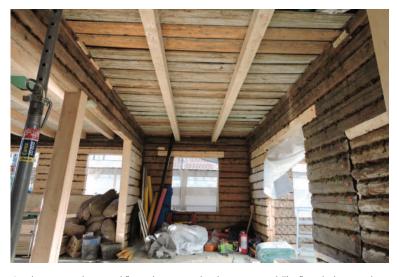
Another room in the ground floor where original ceilings is restored. The floor thickness is about 40 cm, with double crossed floor joist. Technical instalations will fit in between, and the rest will be filled up with cellulose fiber insulation

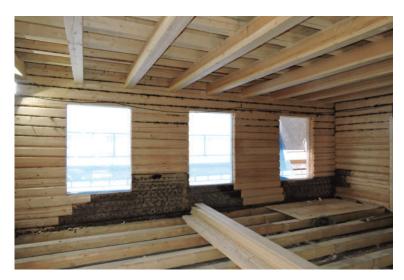
Inside the big hall in first floor, where almost all logs are new. These walls will be visible in the restaurant for several years, until the logs have been comressed and shrinked
